Report on Common Parts (HHSRS) Inspection – The Axis Mercury Gardens

London Borough of Havering

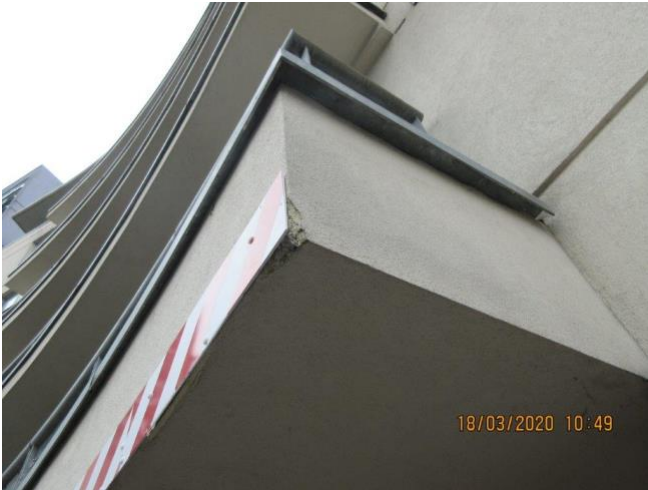
In the car port area beneath Axiom/Zetek an edge was damaged to the underside of the façade where allegedly a delivery van had hit it, exposing the Glassfibre mesh.

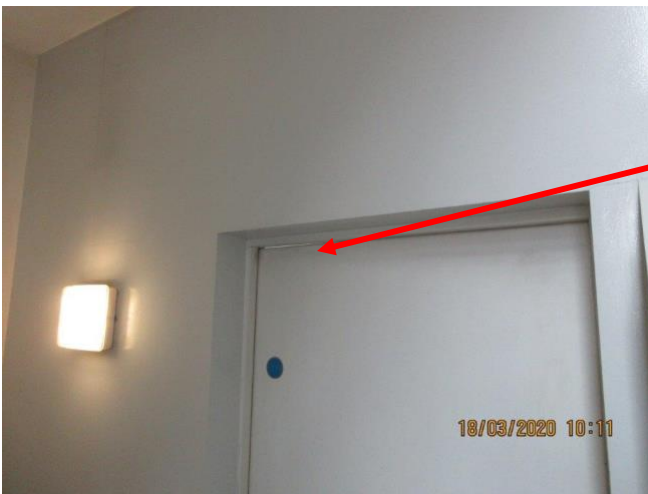
In the ground floor communal entrance to Index and Holly Court a fire door between the ground floor area near the lift and stairs has a fire door separating the exit from the Liberty Shopping centre. The door is locked but poorly hung and daylight can be seen at the top left-hand corner between the door and the frame.

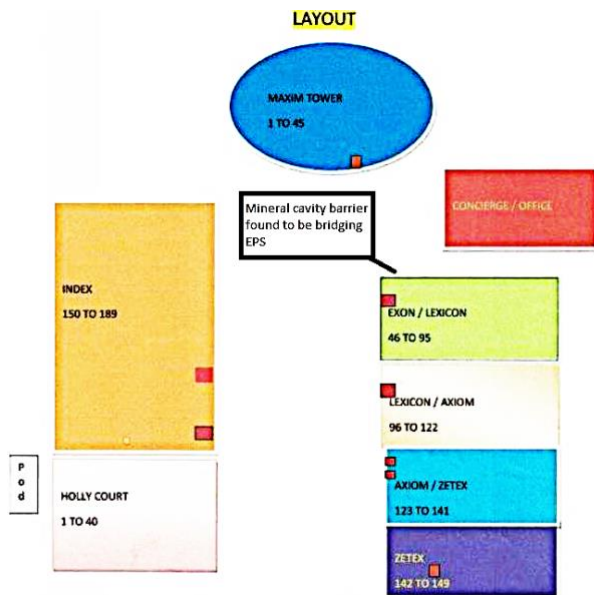
Figure 1 Site layout of Axis development

We cannot be certain that the bridging seen on Exon is not replicated throughout the structures. Occupiers trying to leave from Maxim, Exon, Lexicon, Axiom and Zetek do not have access to escape through the exit behind Holly Court and Index, their means of escape would be through the concierge, negotiating escape from this route is compromised, because in doing so having to travel past the point where the defect was sampled and found on Exon.
