**NON-TECHNICAL SUMMARY**

**ARNOLD'S FIELD, LAUNDERS LANE,**

**RAINHAM, RM13 9FL**

**LONDON BOROUGH OF HAVERING COUNCIL**

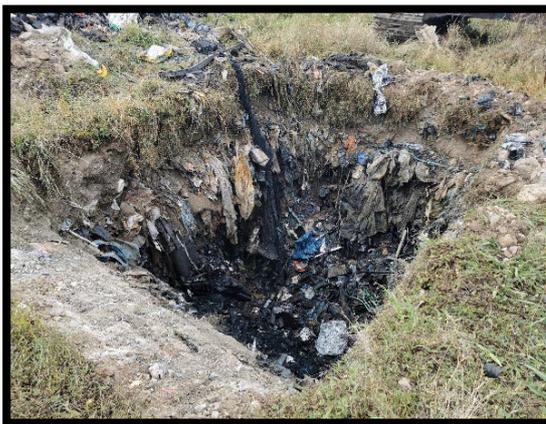
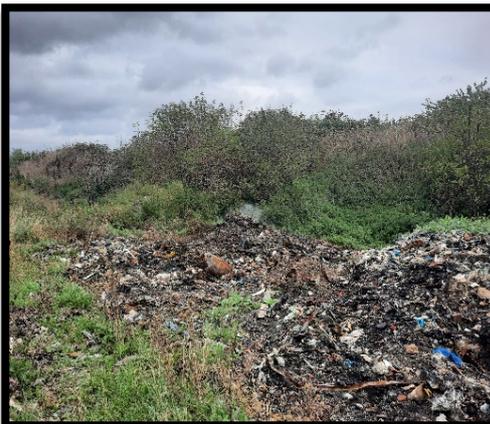
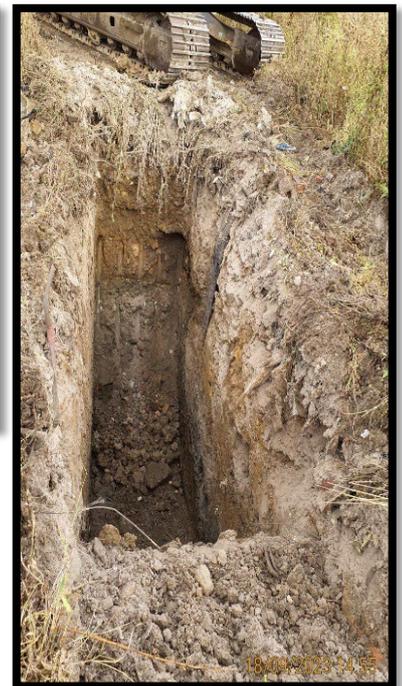
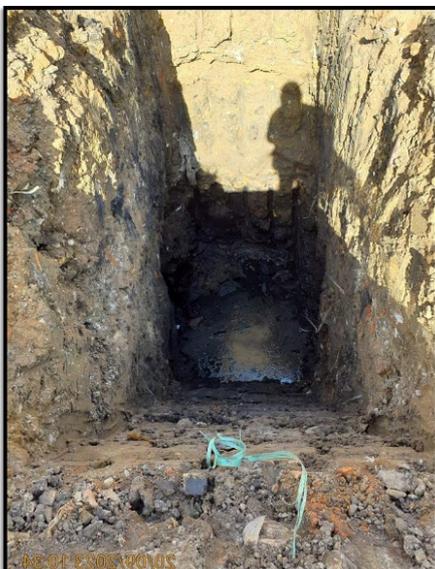
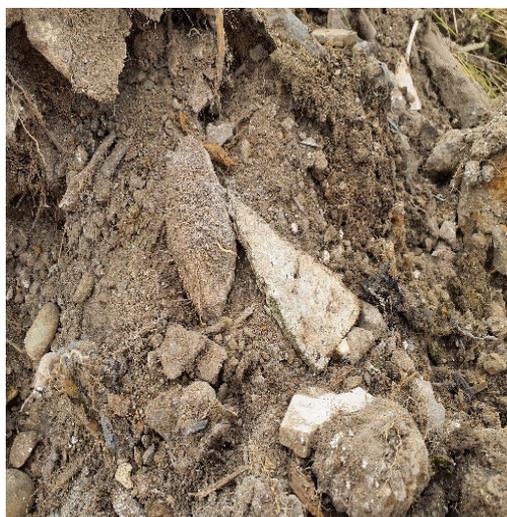
Some photographs of the materials encountered are presented below:

Suspected Asbestos  
Containing Materials (ACM)  
on tracking route between  
TP103 & TP104

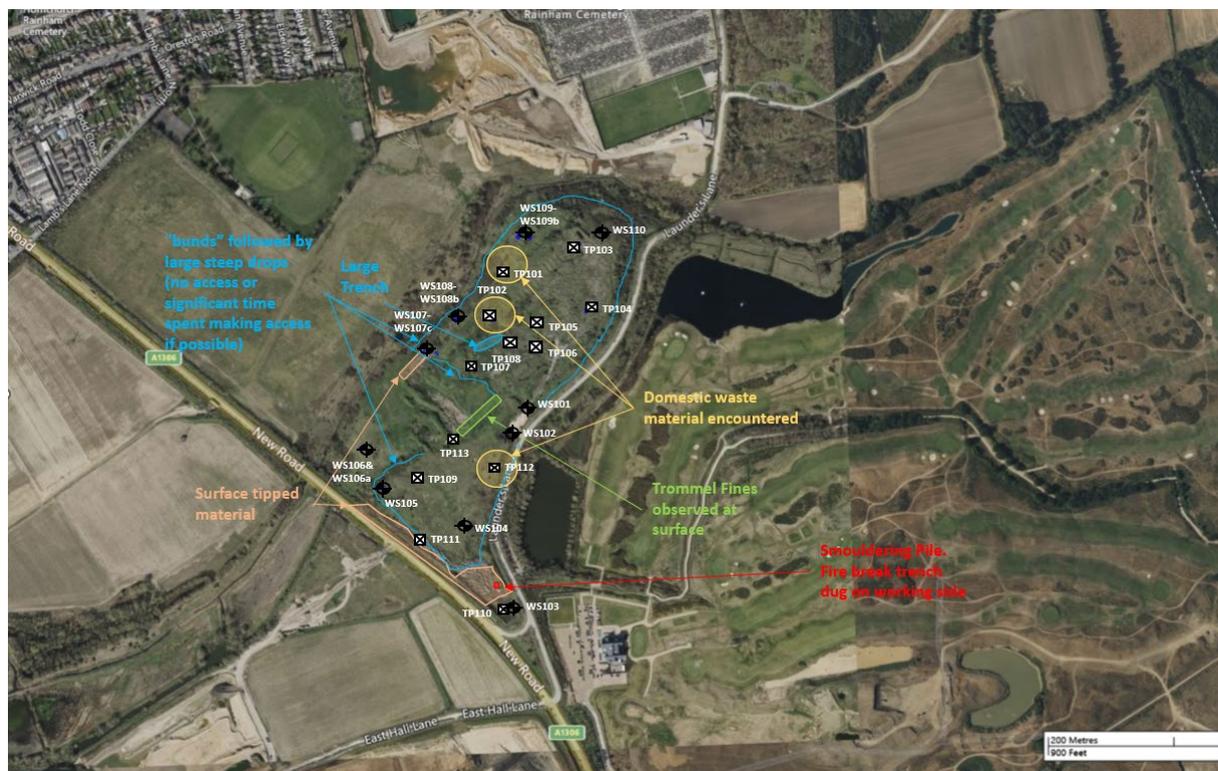
Figure 2 – Key Features Plan

A plan showing some of the key features identified on site is presented in Figure 2 below:
