**RE: AIR MONITORING - Former Waste Site, Launder's Ln, Rainham, RM13 9FL**

## AIR SAMPLING TEST CERTIFICATE

**PHOTOGRAPH APPENDIX**

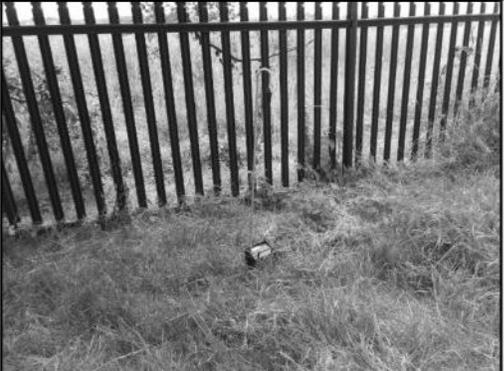
<p>Background air monitoring within Spring Farm Park adjacent to South boundary fence</p> <p>10:26 83411</p> <p>Date/Time: 01/08/2024 10:27</p>

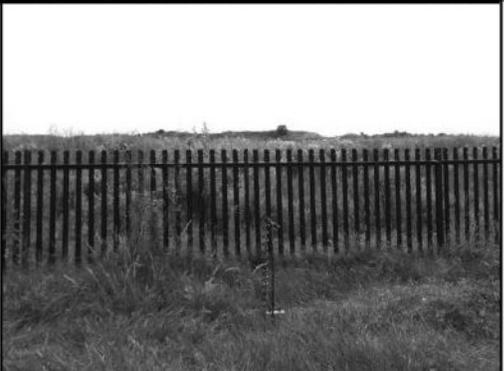
<p>Background air monitoring within Spring Farm Park adjacent to South boundary fence</p> <p>10:28 0863</p> <p>Date/Time: 01/08/2024 10:28</p>

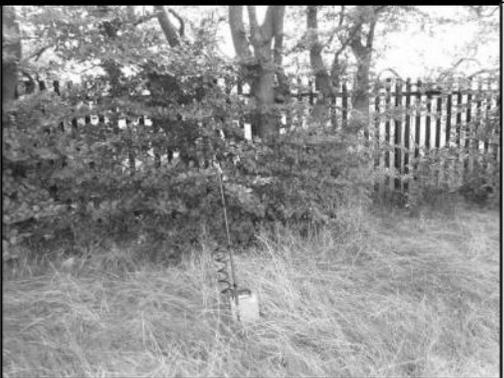
<p>Background air monitoring within Spring Farm Park adjacent to South boundary fence</p> <p>10:29. 0869</p> <p>Date/Time: 01/08/2024 10:30</p>

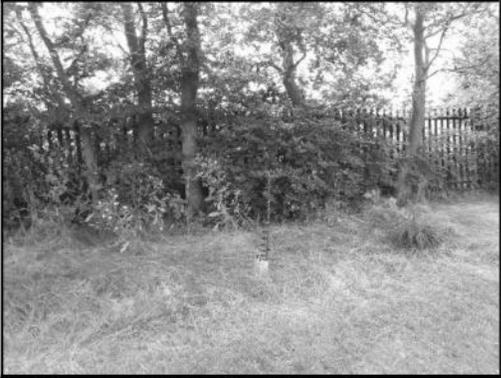
<p>Background air monitoring within Spring Farm Park adjacent to South boundary fence 10:30. 0866</p> <p>Date/Time: 01/08/2024 10:30</p>

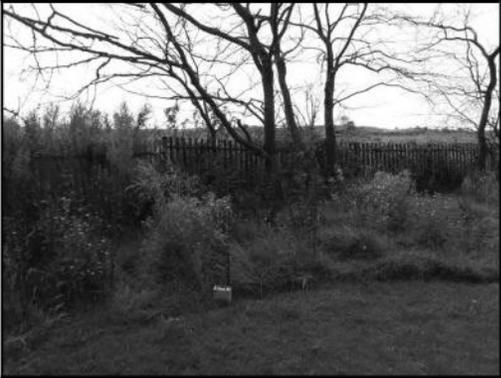
<p>Background air monitoring within Spring Farm Park adjacent to South boundary fence 10:32. 0867</p> <p>Date/Time: 01/08/2024 10:32</p>

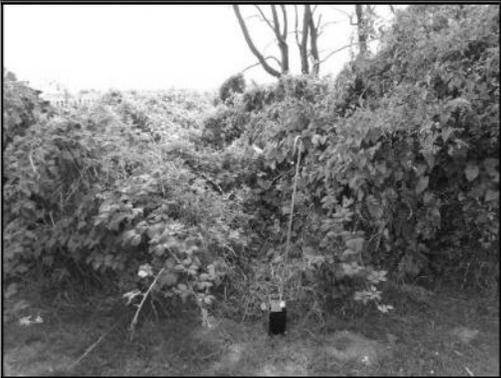
<p>Background air monitoring within Spring Farm Park adjacent to South boundary fence 12:35 83411</p> <p>Date/Time: 01/08/2024 12:35</p>

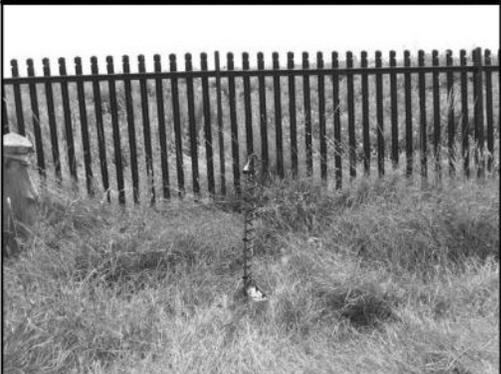
<p>Background air monitoring within Spring Farm Park adjacent to South boundary fence 12:37 0863</p> <p>Date/Time: 01/08/2024 12:37</p>

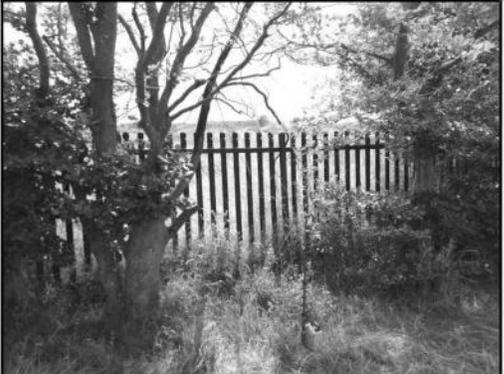
<p>Background air monitoring within Spring Farm Park adjacent to South boundary fence 12:41. 0869</p> <p>Date/Time: 01/08/2024 12:41</p>

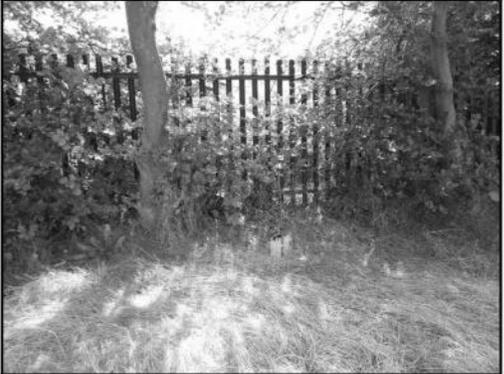
<p>Background air monitoring within Spring Farm Park adjacent to South boundary fence 12:43. 0866</p> <p>Date/Time: 01/08/2024 12:43</p>

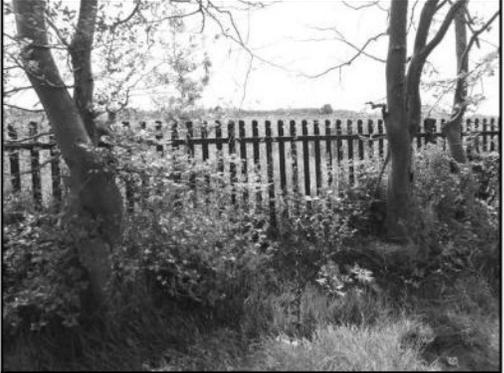
<p>Background air monitoring within Spring Farm Park adjacent to South boundary fence 12:46. 0867</p> <p>Date/Time: 01/08/2024 12:46</p>

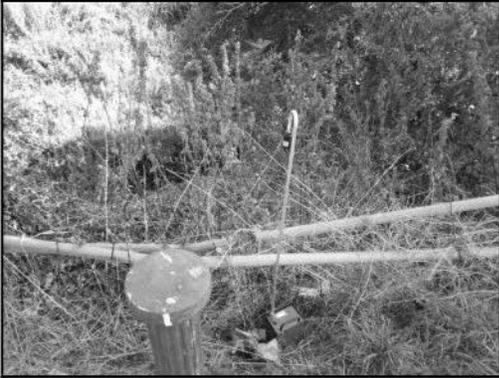
08:33, Sample 0 15, Pump 83408, Background air test upon New Road	Date/Time: 29/08/2024 08:33

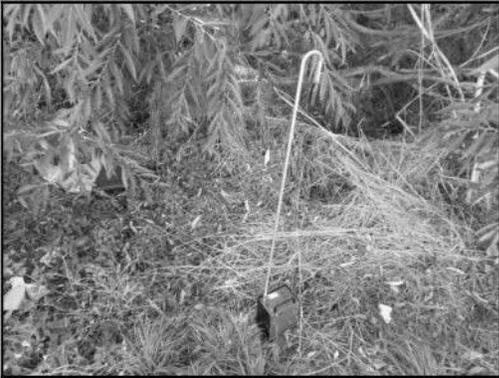
08:36, Sample 0 16, Pump 83409, Background air test upon New Road	Date/Time: 29/08/2024 08:36

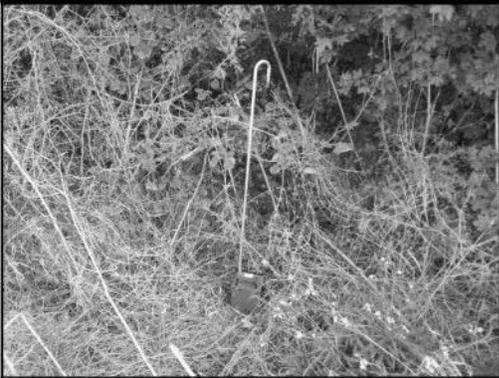
08:41, Sample 0 17, Pump 83411, Background air test upon New Road	Date/Time: 29/08/2024 08:41

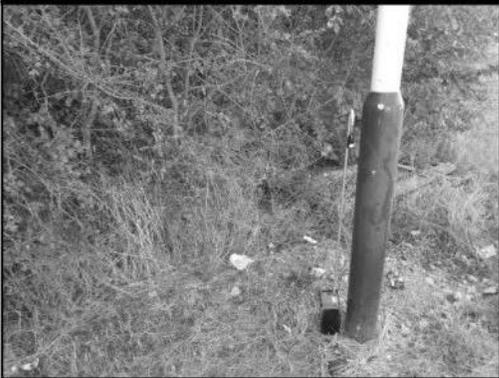
08:43, Sample 0 18, Pump 83412, Background air test upon New Road	Date/Time: 29/08/2024 08:43

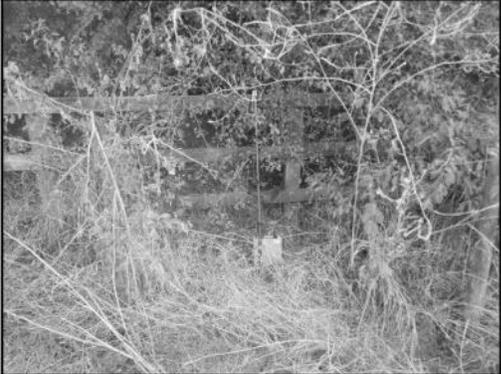
<p>08:47, Sample 019, Pump 0869, Background air test upon New Road</p> <p>Date/Time: 29/08/2024 08:47</p>
	<p>08:48, Sample 020, Pump 2318, Personal air monitoring upon</p> <p>Date/Time; 29/08/2024 08:48</p>
	<p>08:54, Sample 021, Pump 2318, Personal air monitoring upon</p> <p>Date/Time: 29/08/2024 09:54</p>

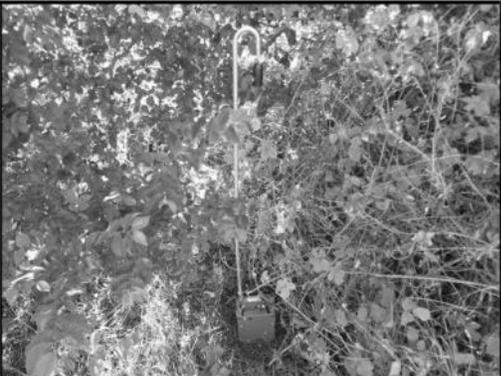
<p>09:59, Sample 022, Pump 83408, Background air test upon Launders Lane South</p> <p>Date/Time: 29/08/2024 09:59</p>

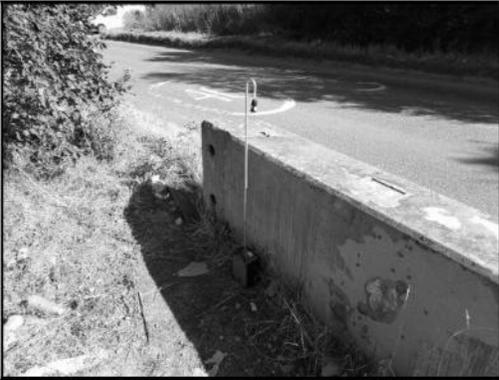
10:00, Sample 023, Pump 83409, Background air test upon  
launders lane South

Date/Time: 29/08/2024 10:00

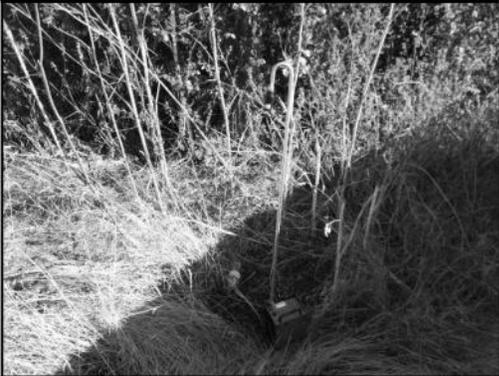
10:01, Sample 024, Pump 83411, Background air test upon  
Launders lane South

Date/Time: 29/08/2024 10:01

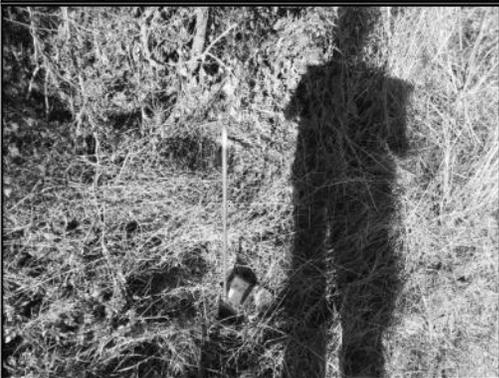
10:02, Sample 025, Pump 83412, Background air test upon  
Launders lane South

Date/Time: 29/08/2024 10:02

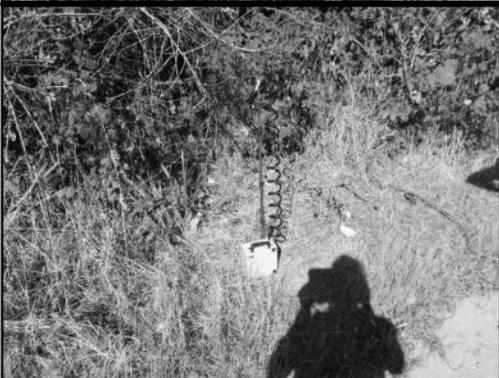
10:03, Sample 026, Pump 0869, Background air test upon  
launders Lane South

Date/Time: 29/08/2024 10:03
