Capping options appraisal

Arnold's Field

Client: London Borough of Havering

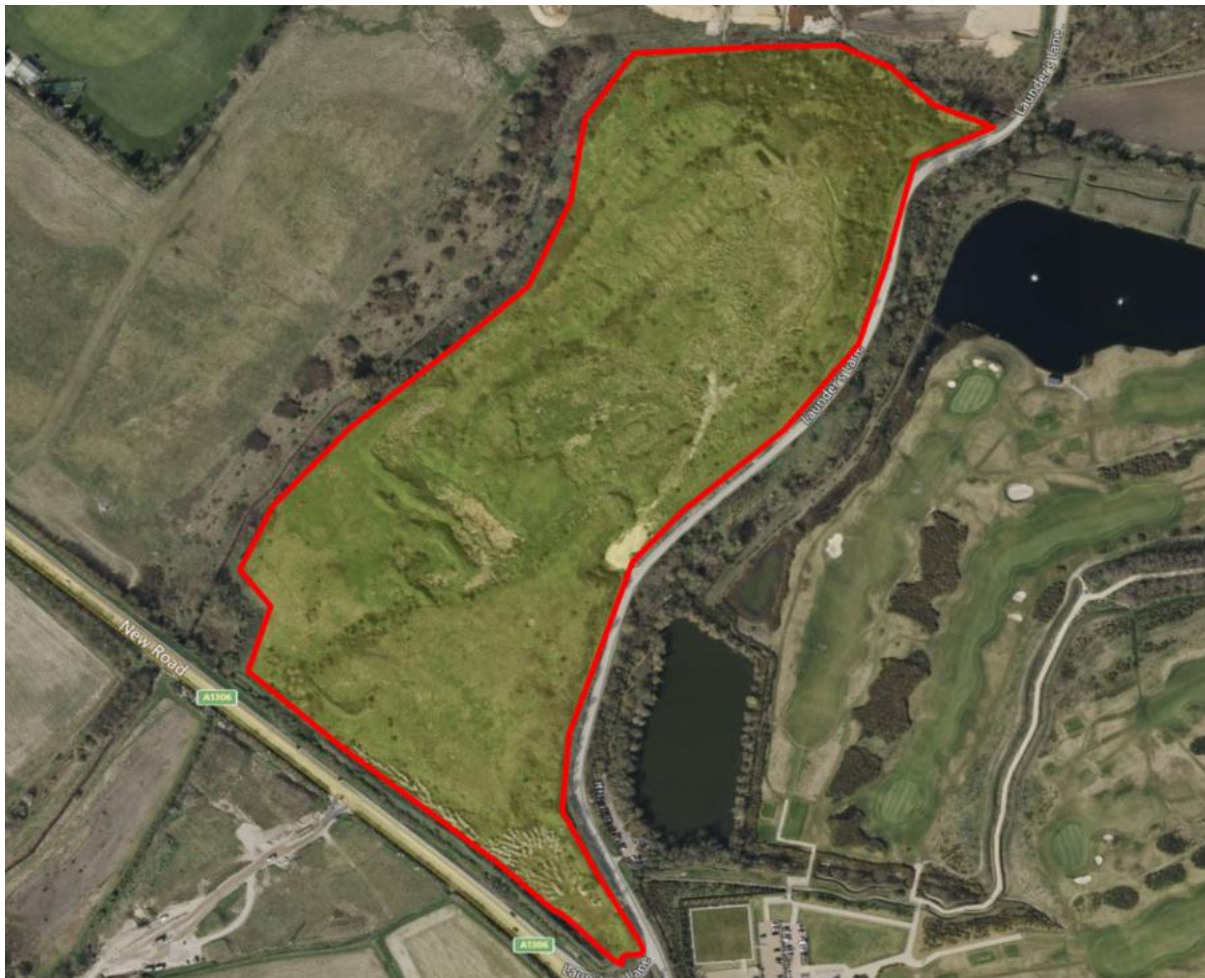
Figure 1: Site location and layout

The site location and layout are presented in Figure 1, below. It is an irregular polygon of approximately 17 hectares, centred around National Grid Reference 554116 182008. It is bounded to the north and west by a watercourse (Common Watercourse), and to the south and east by roads (A1306 and Launder's Lane respectively).

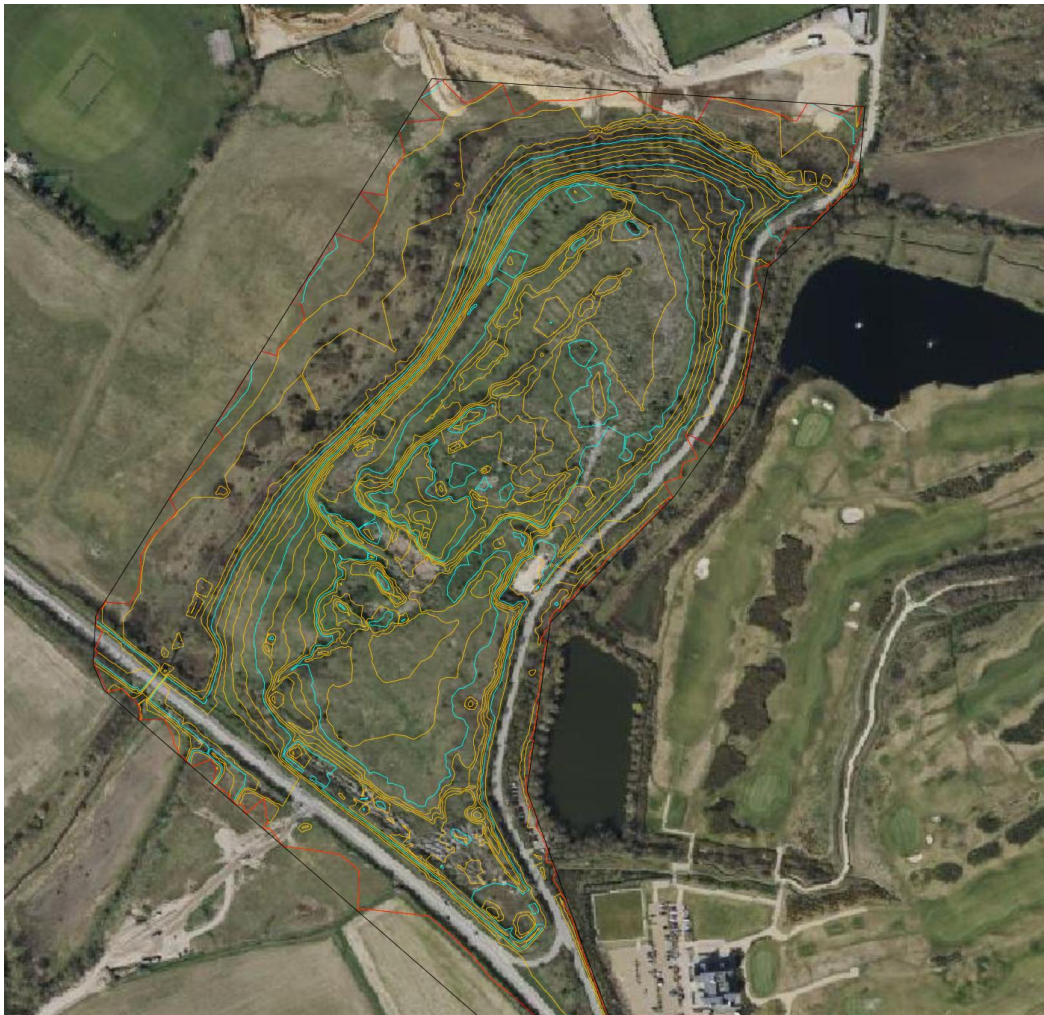
Figure 2: Approximate topography of site, excluding bunds and ditches

The current levels across the site based on spot heights are presented in Figure 2, however, there are a significant number of steep sided ditches and bunds.
