## **Arnold's Field**

### **Technical Note on Site Investigations**

**March 2012**

Client: Environment Agency  
Project: Arnold's Field  
Document Title: Technical Note on Site Investigations

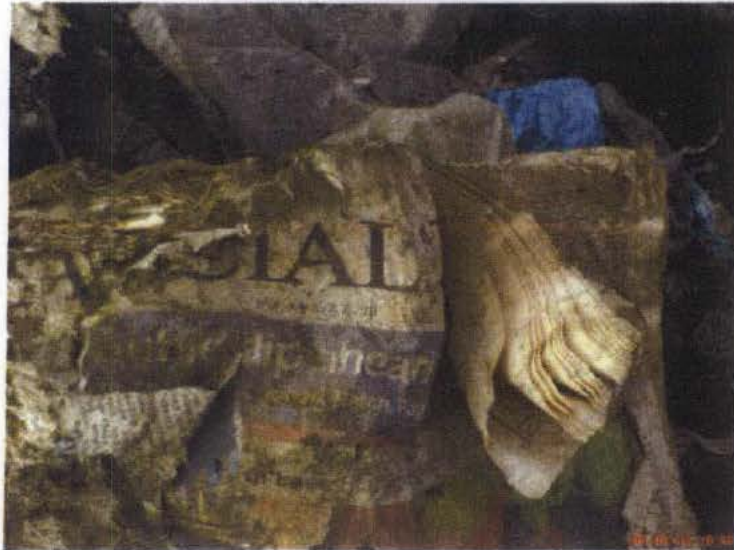
The recent landfilled waste comprised domestic and commercial waste including documents, wood, paper, glass, plastic, mattresses, pieces of furniture or equipment, cables, netting, clothing and other fabrics and occasional empty medical waste packaging. Little evidence of substantial decomposition of the material was observed indicating recent deposition. It was often possible to read dates from documents, newspapers or magazines. These were frequently dated as recently as 2011. The EA Environmental Crime Team officer collected samples of such materials in evidence bags.

**Plate 1: Newspaper Dated June 2<sup>nd</sup> 2011 Recovered From Waste**

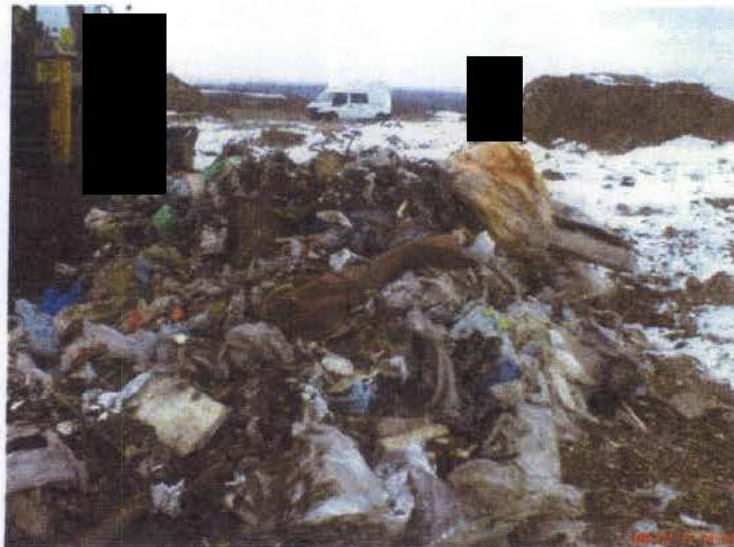
**Plate 2: Typical Waste Material Excavated From Trial Pit**

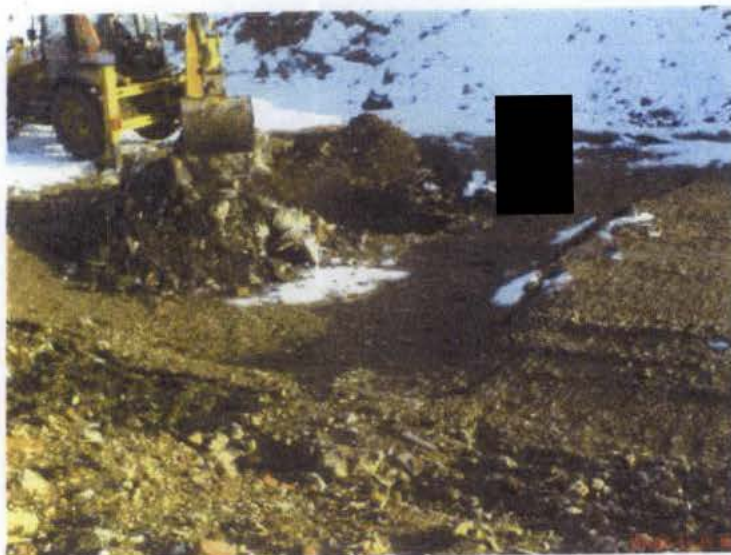
On excavation, the waste was frequently observed to be warm and emitting vapour suggesting decomposition and the production of landfill-type gasses. The weather during the investigations was cold with a snow cover present throughout the week of the works. It was noted that snow melt frequently occurred in areas of recent waste, suggesting that the decomposition of the waste was warming the overlying ground.

***Plate 3: Area of Subsidence with Snow Melt Over Area of Recent Waste***

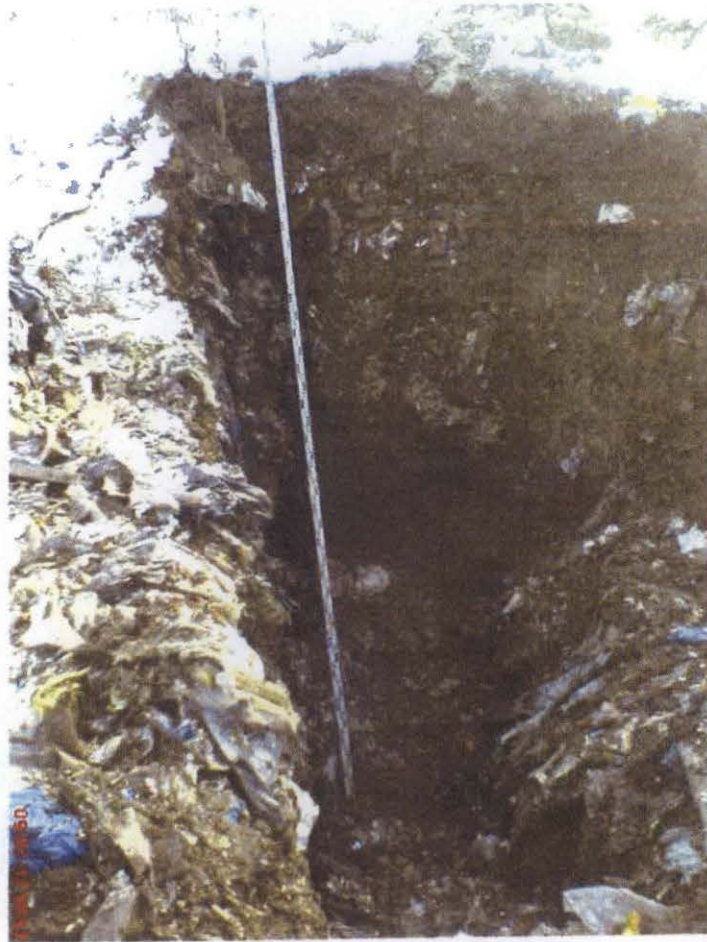
During the works it was not possible to prove the full depth of the recent landfilled waste. Trial pits excavated as deep as 4m below ground level (mbgl) did not reach the full depth of the waste.

*Plate 4: Waste Extended to the Base of Trial Pits*

It is recommended that the extent of recently deposited waste is investigated further. There are various ways in which this could be done. It is considered that an effective method would involve a combination of geophysical investigations to estimate the lateral extent of waste across the site as a whole followed by a series of boreholes and trial pits to investigate the depth and composition of the waste where it has been identified.
