Report on Common Parts (HHSRS) Inspection – The Axis Mercury Gardens

London Borough of Havering

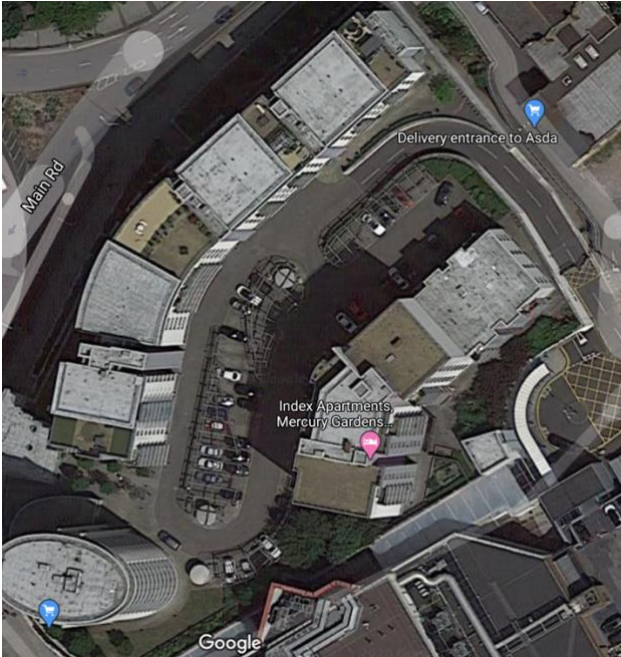
Figure 1 Site layout of Axis development

We cannot be certain that the bridging seen on Exon is not replicated throughout the structures. Occupiers trying to leave from Maxim, Exon, Lexicon, Axiom and Zetek do not have access to escape through the exit behind Holly Court and Index, their means of escape would be through the concierge, negotiating escape from this route is compromised, because in doing so having to travel past the point where the defect was sampled and found on Exon.

According to LACoRS Fire Safety Guidance (p.18 6) that if there is no practical way of avoiding escape into a courtyard from where there is no exit it should be at least as deep as the building is high. Therefore, the car park area in the middle overshadowed by the surrounding buildings is not an ultimate place of safety.
